[8] SELF DIAG AND TROUBLE CODE

1. Self diag

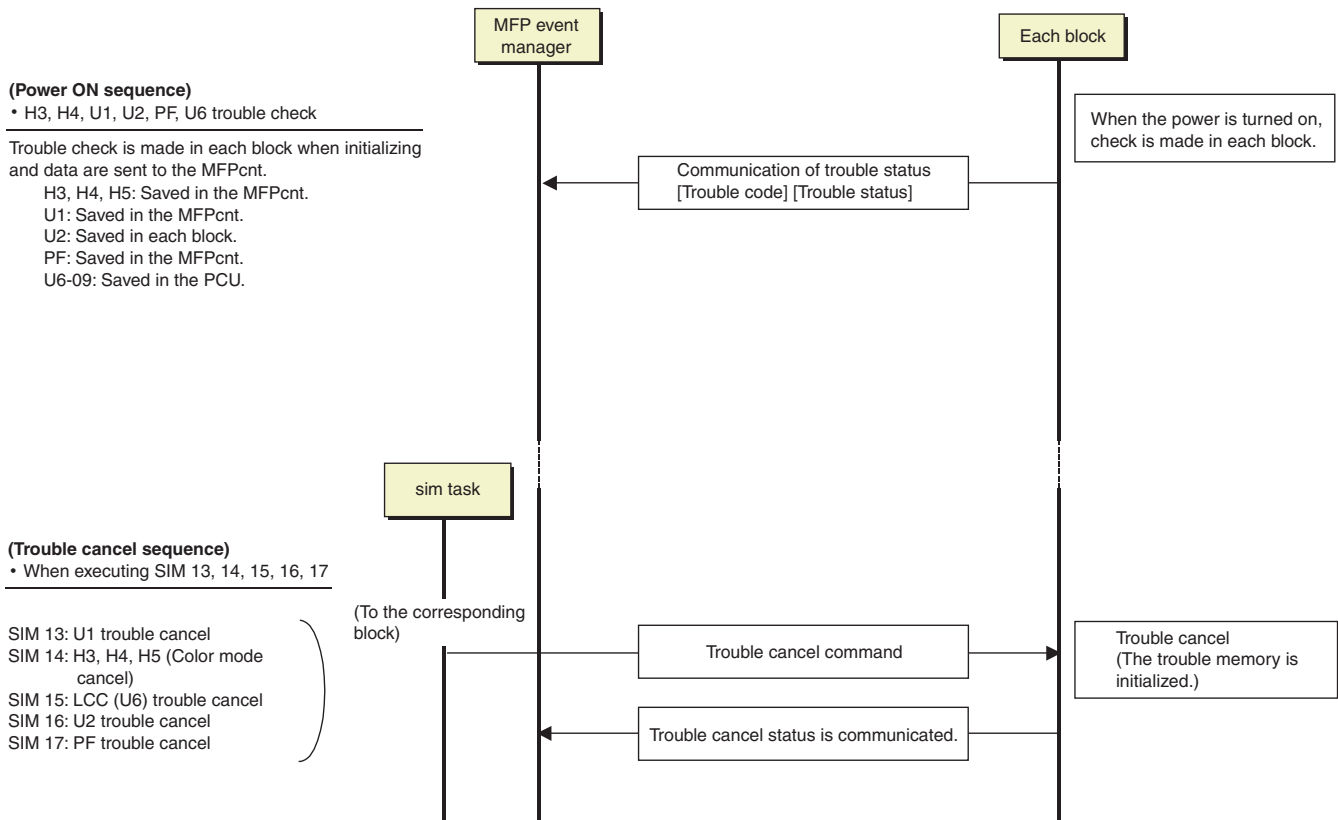
(2) Power ON trouble detection sequence.

- When the power is turned ON and each trouble of H3, H4, H5, U1, U2, PF, U6 (09) is stored, it is judged as a trouble immediately.
